SIAMP 50 Dual Flushing Valve Cable Operated

Fault Finding Guide

Troubleshooting: Dual Flush Valve Not Flushing

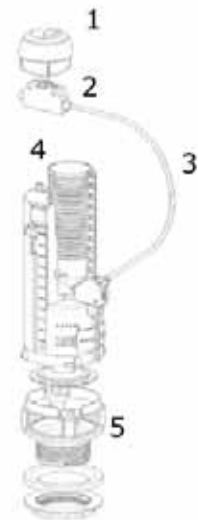
- 1 - Push Button
- 2 - Cable Housing
- 3 - Cable
- 4 - Overflow
- 5 - Strainer
